Rheinmetall Frame Repair
Austin, Texas June 2019
Everett E. Henderson Jr

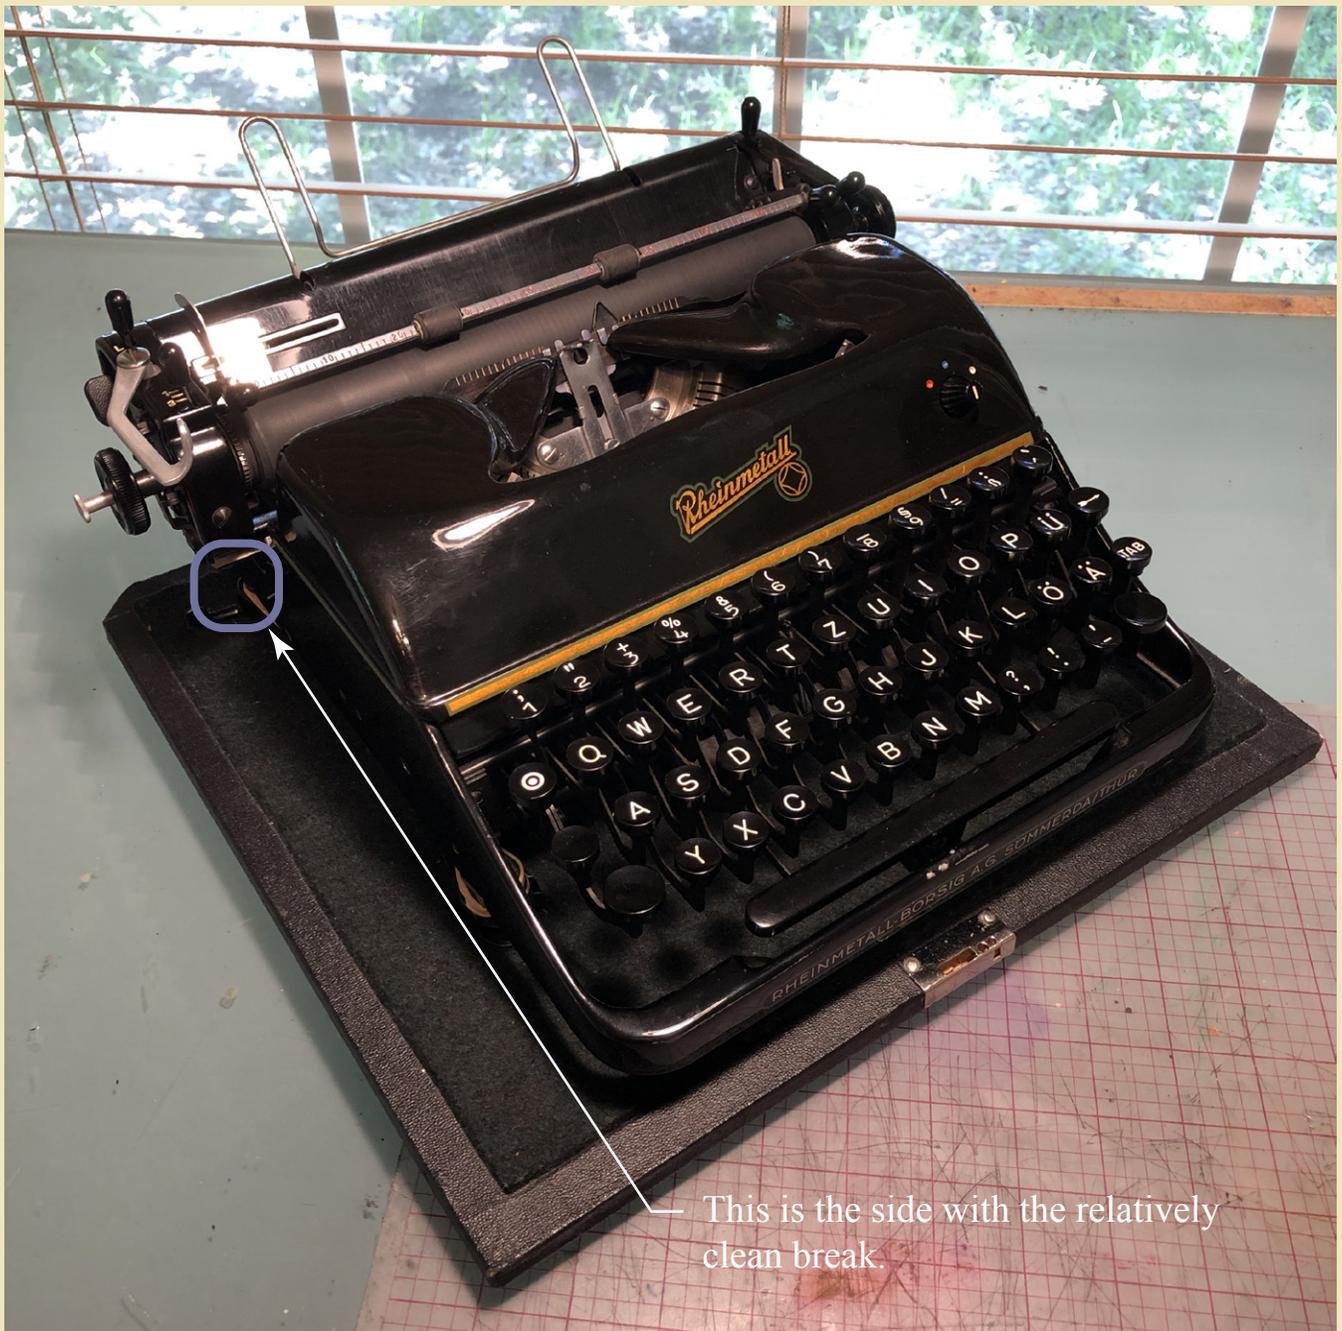
— This is the side with the relatively clean break.

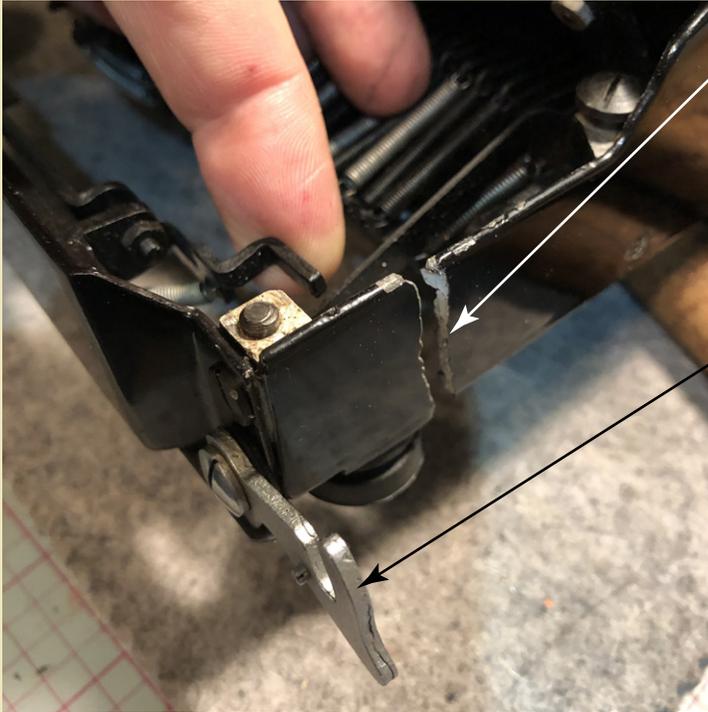
The break was relatively clean and the frame was not bent. The aluminum frame in this area is thin and it makes sense that it would have broken here.

One of the two latches that made the removal of the carriage and platen assembly easy.

I wanted to strengthen the break because I did not want the carriage return to vibrate the repair over time.

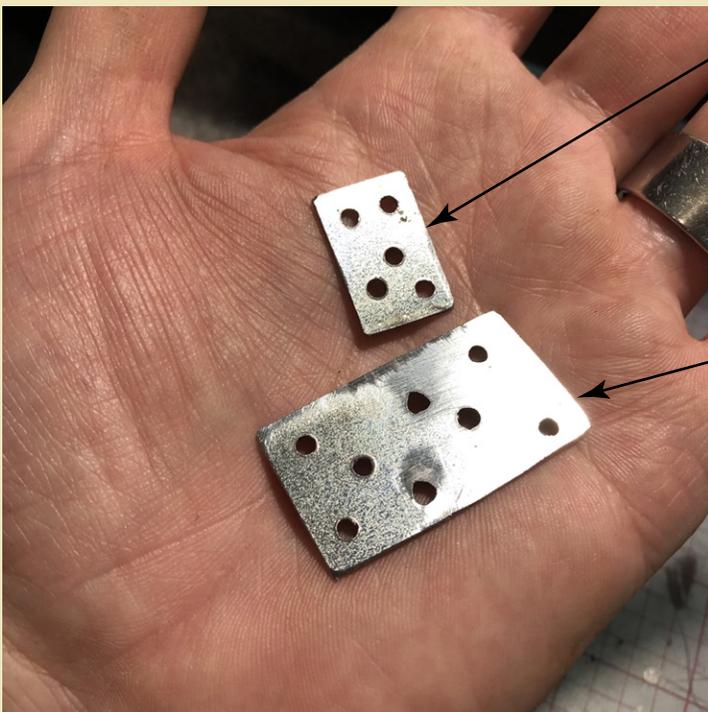
Inner plate / splint, This was created to fit within the cast aluminum frame. The drilled holes allowed for the “cold weld” (J-B Weld) epoxy to “bite” into the splints.

Outer plate / splint.

I was tempted to use mechanical fasteners and bolt through the frame. I decided not to do this because I felt it would have been a little overkill.

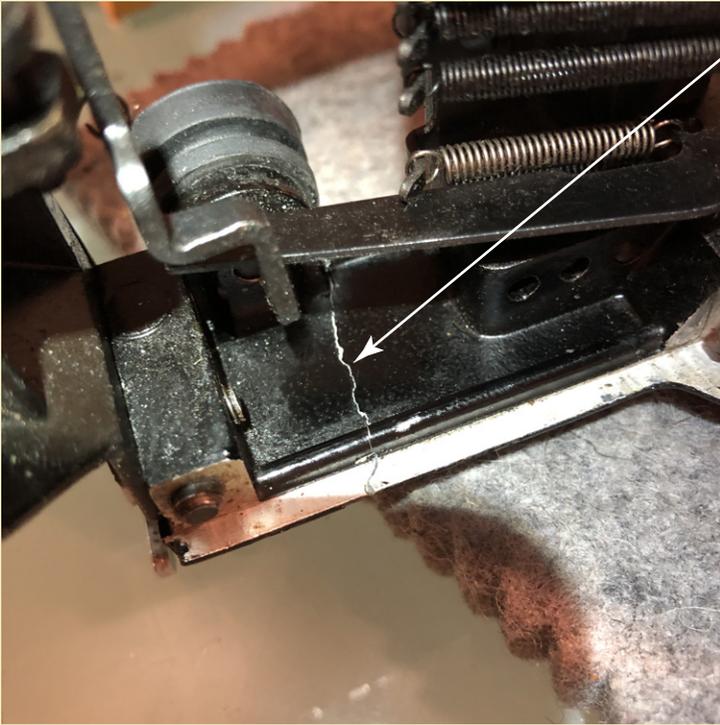
The break was relatively clean and the frame was not bent. A clamp was used to keep tension on the joint. I wanted to splint the inside of the frame before working on the outside splint.
